MANCHESTER ASSOCIATION OF ENGINEERS

An illustrated talk on the
CONVERSION
of
THE VICTORIAN CITY Hall
into the
AIR & SPACE MUSEUM

by **Hubert Dickson CEng. FInstrucE. MMAE**

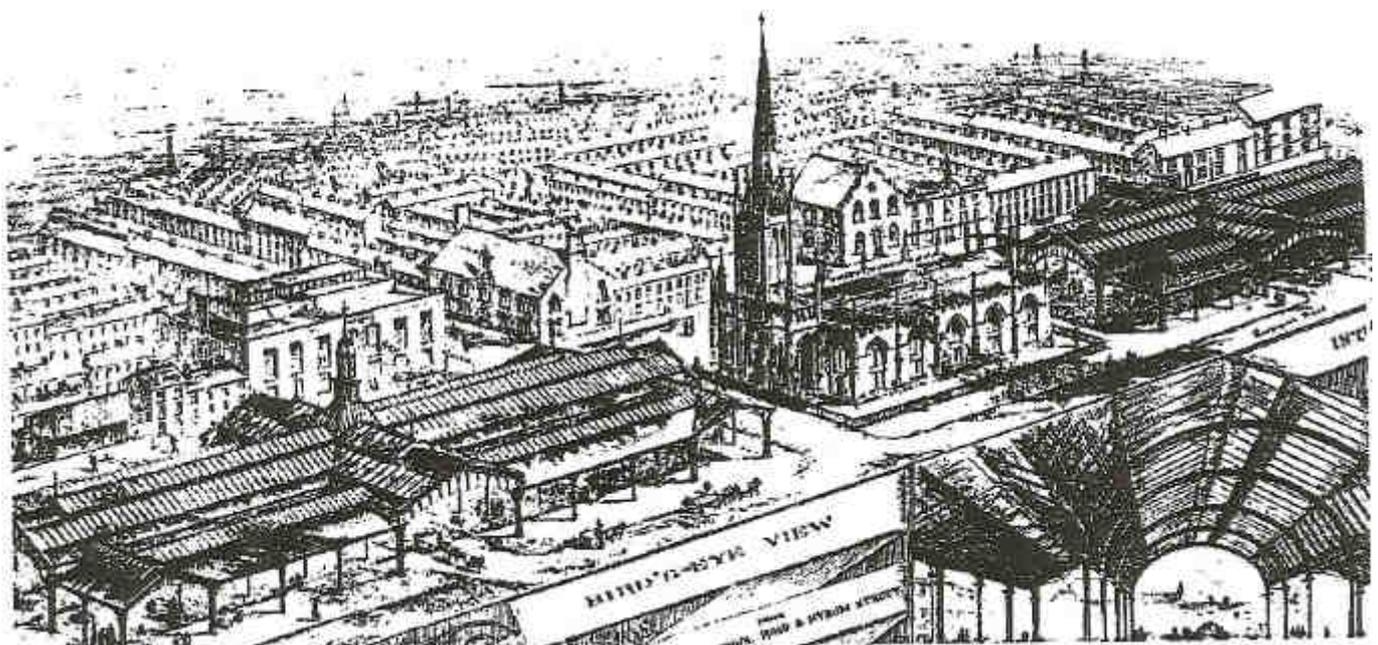
Fig 1

The two Market Halls, therefore, were designed as separate buildings, but similar in their style, construction and appearance. (See Fig. No.1)

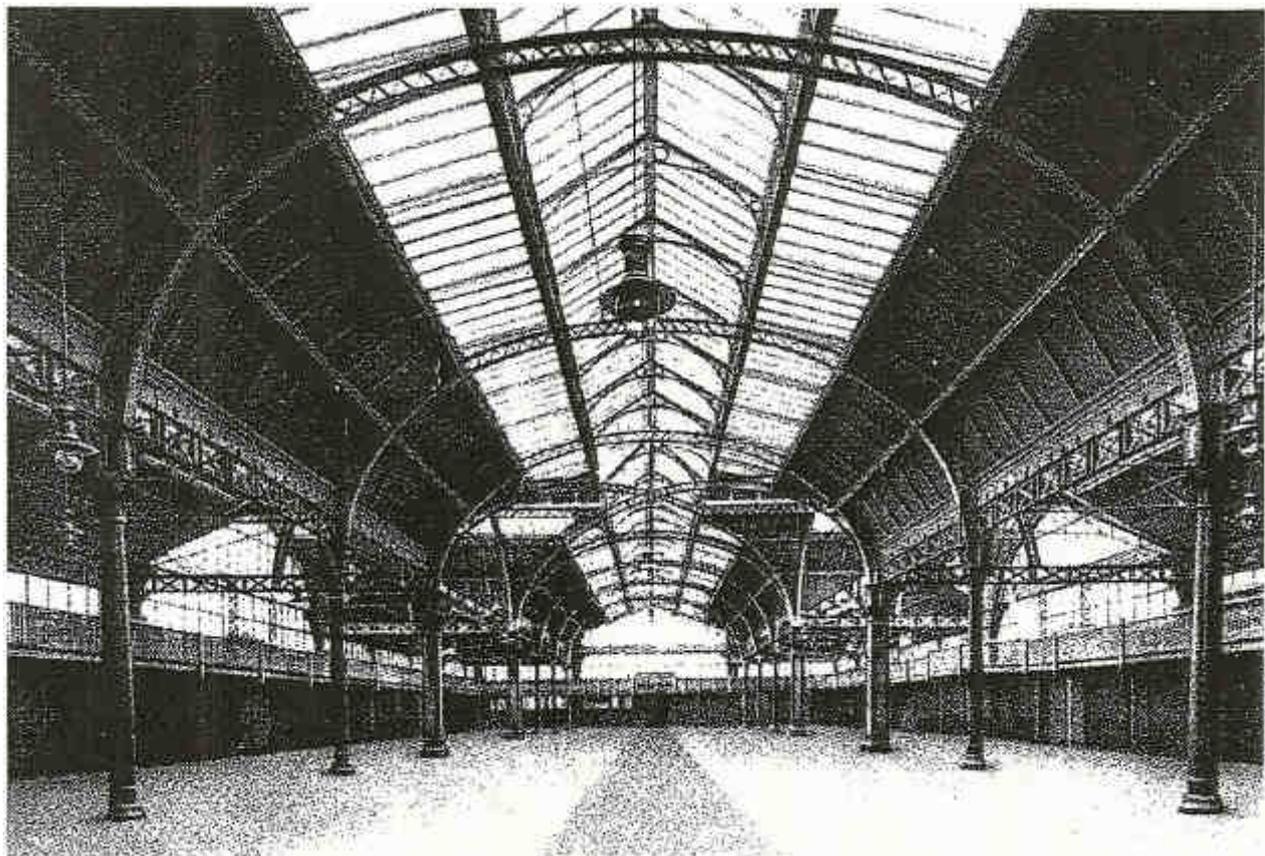
Fig 2

These arches were constructed to embrace the latest technology of wrought iron Latticeworks; providing an ambience of spaciousness and lightness, while rising 'up from the caps of slender cast iron columns to a height of 40 feet (12m) above the market floor. (See Fig.No. 2)

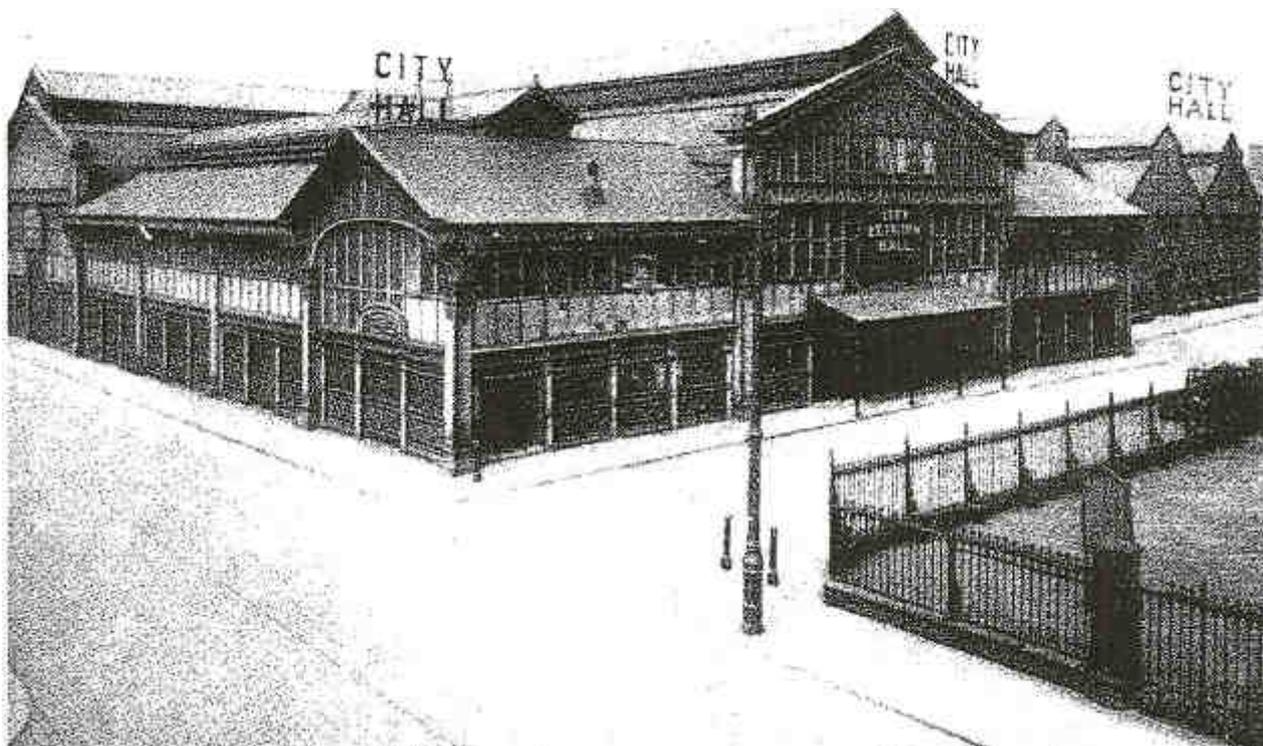
Fig 3

An entranceway into the exhibition hall was created in the east gable facade, and this feature was enhanced with an external, canopy-type, covered over porch way. (See Fig.No.3)

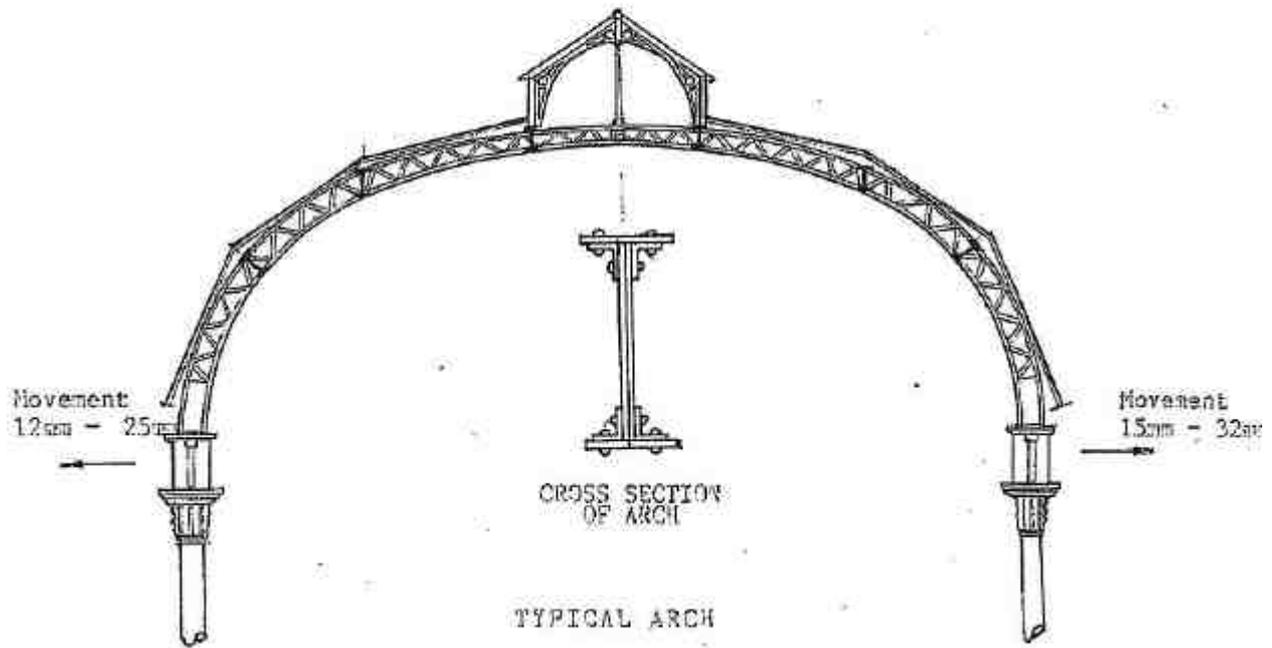
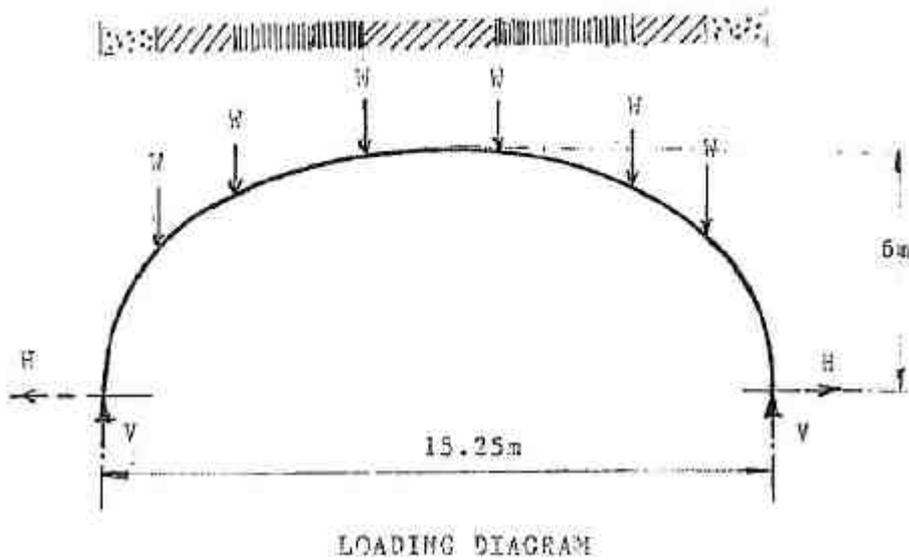
Fig 5

ANALYSIS of the ARCH

Variations in Superimposed Loadings

50° - 57° Nominal 3 lbs/sq.ft

At this stage, the City Architect's structural engineers carried out an analytical check on the design of the 50 ft. (15.3m) span wrought iron lattice arched member, and were astonished by their findings. Technically, the arched frameworks were found to be just adequate to carry the dead weight of the roof coverings, with little capacity left over to cope with incidental loadings, such as maintenance loads, heavy snow falls or strong gale force winds.

In the case of the Market Hall/ City Hall structure, no metal tie bars were included in the initial construction process and the thrust from the arches, as they flexed, should, therefore, have been resisted by robust frameworks built at each side of the main aisles. This did not happen. (See fig.No.5)

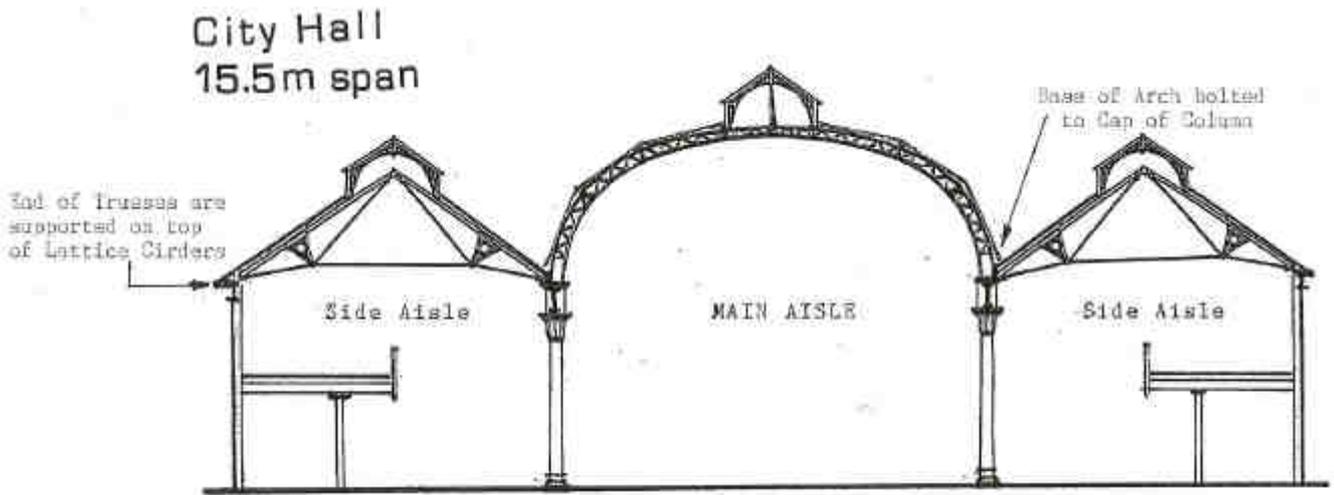
Fig 6

TYPICAL CROSS SECTION

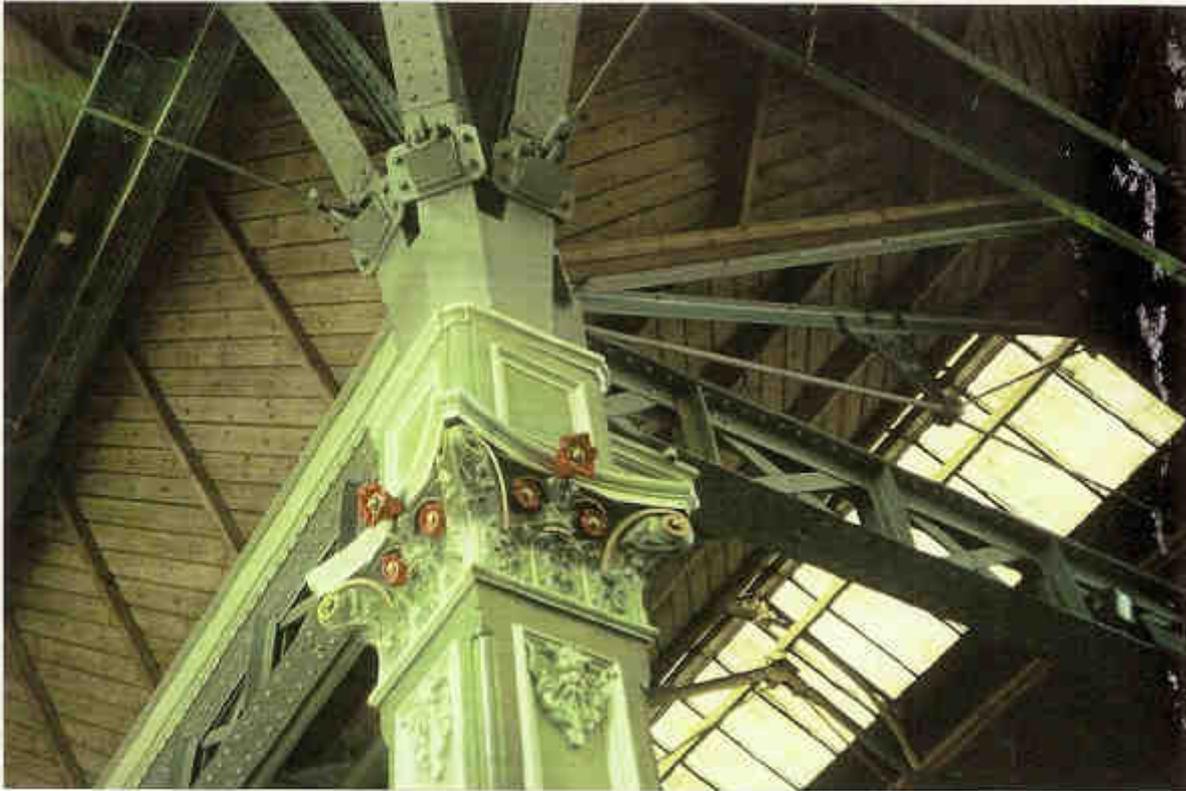
2

Corinthian Capital on a Square Column
Note the bases of three arches springing from
the column, with the tie bars and brackets.

- (i) To provide metal tie bars at the springing level of all the curved arches, to hold them in their present position, and prevent any further lateral movement taking place in the future.
- (ii) To introduce a restraining member at the apex of the side aisle trusses, to run across the ridge point and tie each rafter together to prevent further buckling taking place.
- (iii) Sore consideration was necessary, during the restoration process, to reducing the overall dead weight of the roof coverings, in order to meet the present day statutory requirements for superimposed loadings.
- (iv) If these recommendations were not accepted it could result in the structures being classed as unacceptable under current Building Regulations.

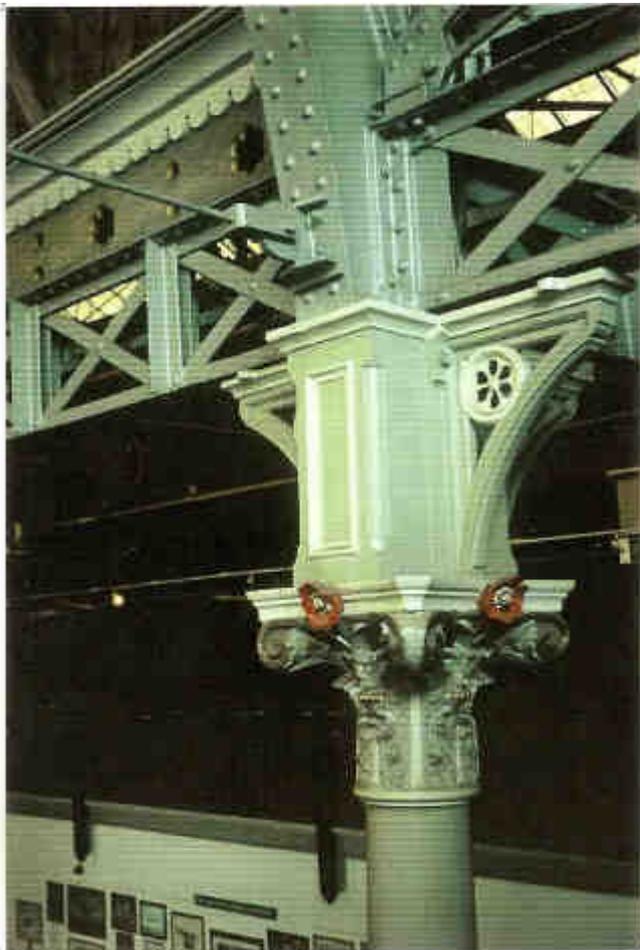
View of Corinthian Capital on
Circular Column.

Note the W1 Lattice Girders
and base of the arch resting
on the column, with the tie
bar and bracket in position.

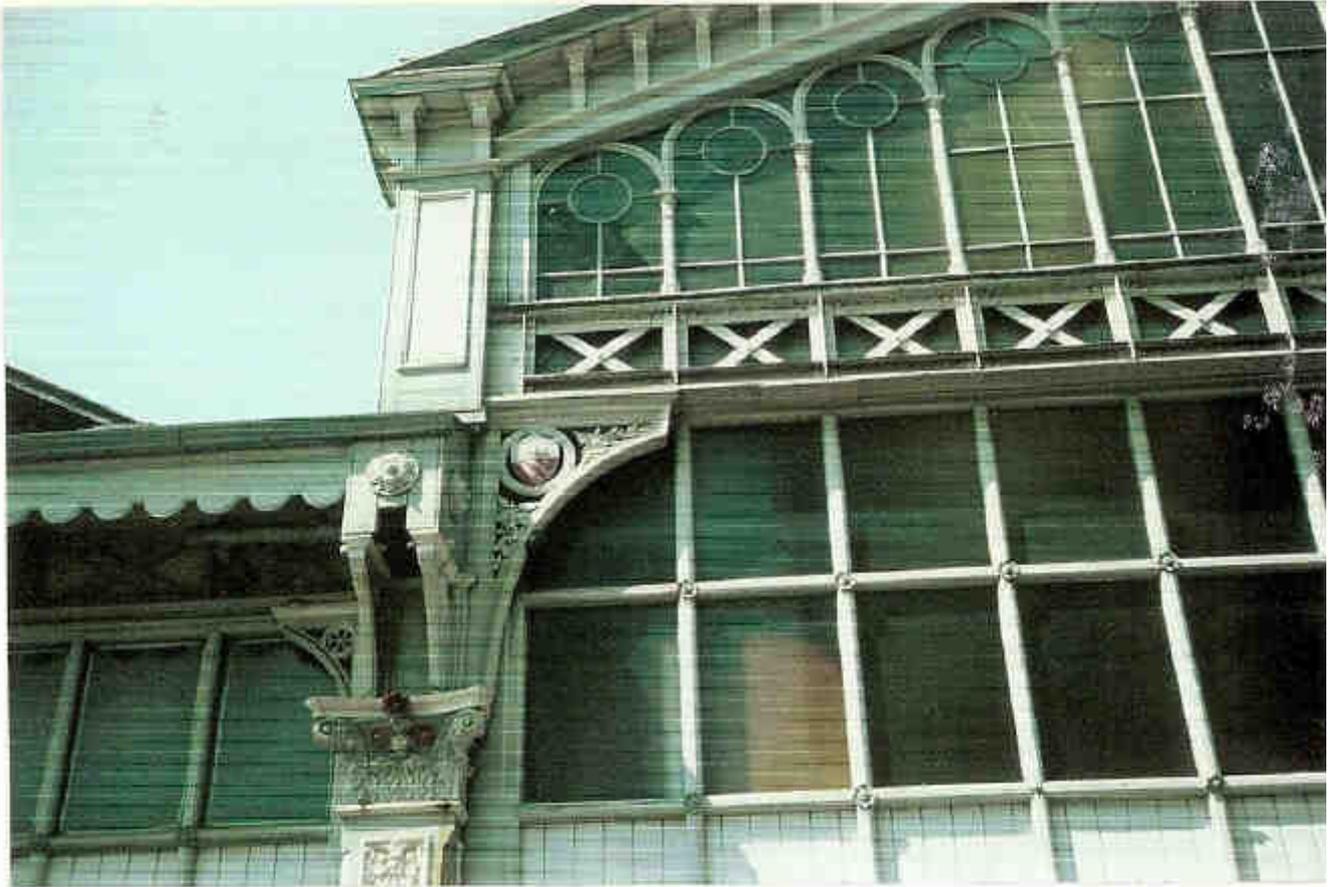
View of an ornate cast iron bracket supporting the Eastern Gable WI Lattice Girder.

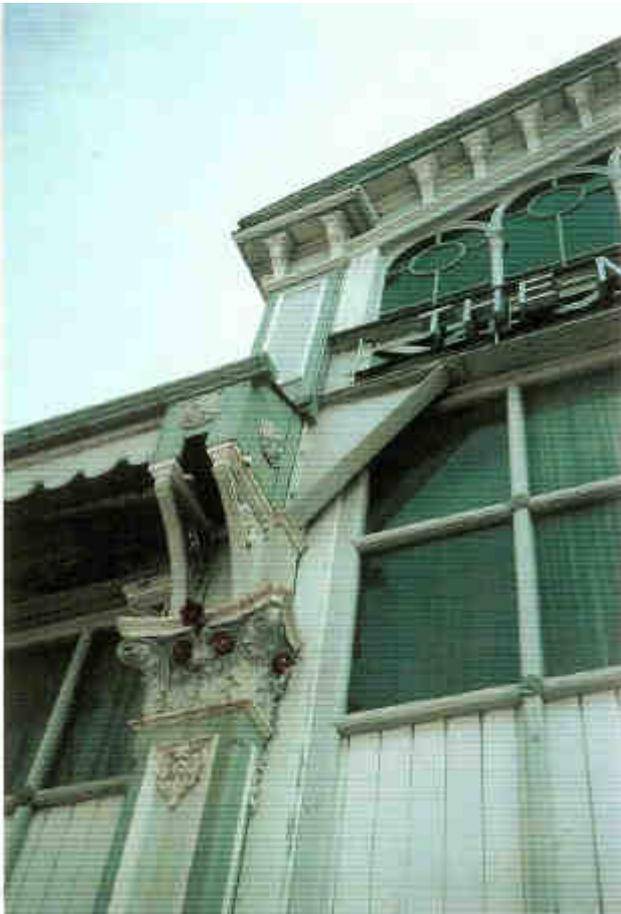
④

Fabricated welded mild steel bracket on the Western Gable as a substitute for the original ornate cast iron supporting bracket.

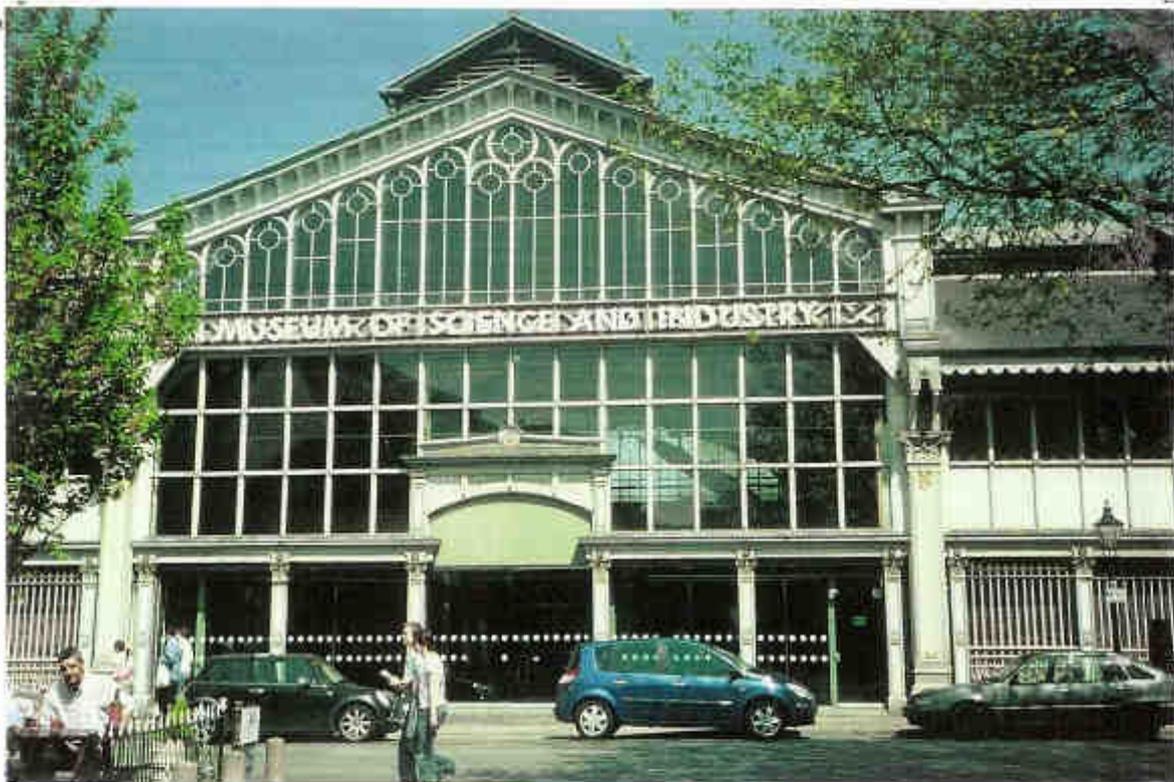
5

View of South Gable
With the 'Historical Railings' replaced by
full height clear glazing.

The architects and the Air and Space team wanted to leave this enlarged entrance as a feature - to facilitate the removal and acceptance of the larger aircraft for display. The idea was to provide a demountable glazed frontage, which could be readily removed, and would also allow the passers-by to view the exhibits inside the museum.

The English Heritage architect rejected these proposed changes to the original Victorian facade; only agreeing to a compromise, whereby the features of the original facade would be rebuilt and retained, but the lower level would be infilled with clear glazing, instead of brickwork, and the wrought iron railings would not be replaced across the opening.

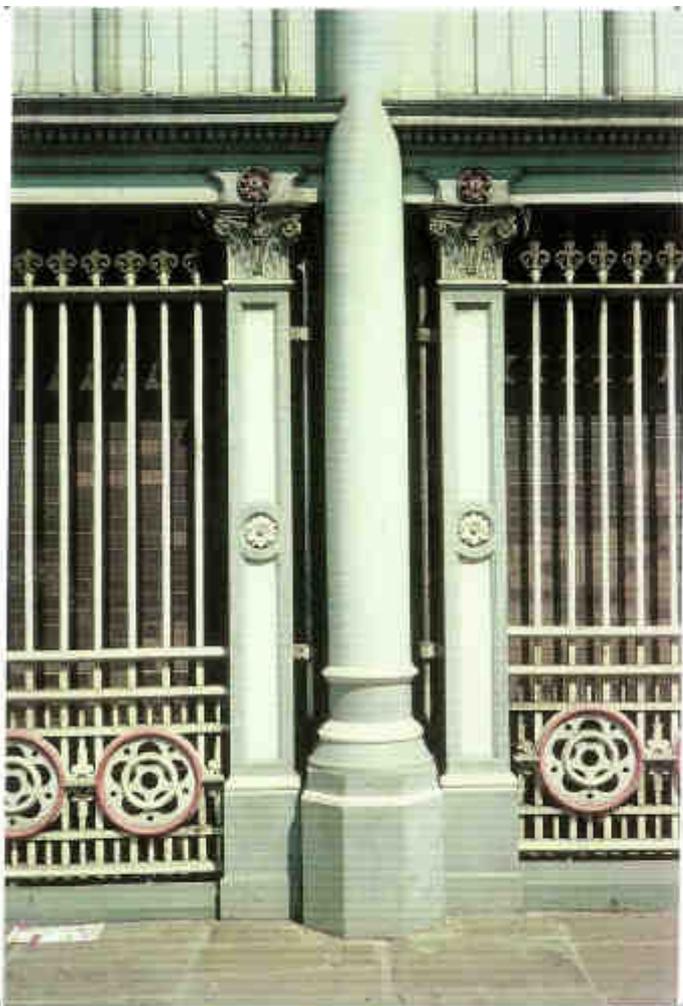
6

External Columns.
Showing the 'rose'
embellishments and
'Historical Railings'.
