# **Design and Fabrication of the new Wembley Stadium Roof**

**Presented by Dr A P Mann**

**On Thursday November the 16th, 2006**

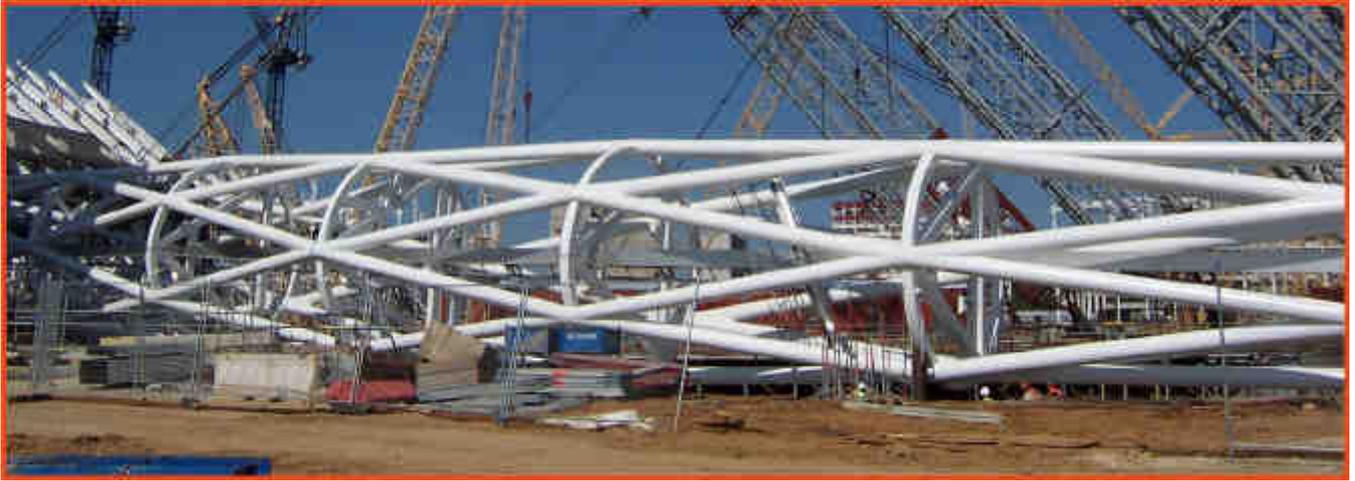
Fig 3. Segment of Truss

A segment of the arch is shown in Figure 3, the sequence was to build the diaphragms first with stub tubes attached, then to place the diaphragms in position on the ground then to weld the tubes in-between, the amount of welding is very high and the difficulties of achieving alignment tolerance were significant. In its final condition, the arch is hinged 'in plane' at the base but to build it on the ground and raise it up, the arch had also to be hinged at 90o to this and so a rather complex doubly hinged temporary joint capable of rotation and capable of taking all the temporary forces was required at the arch ends. In its final state, the arch is held in place by cables and there are also cable attachment cleats for supporting the roof under. Thus there are lugs built in at intervals for cable attachment points. To cope with lifting and restraining the arch before completion, additional lugs were required.

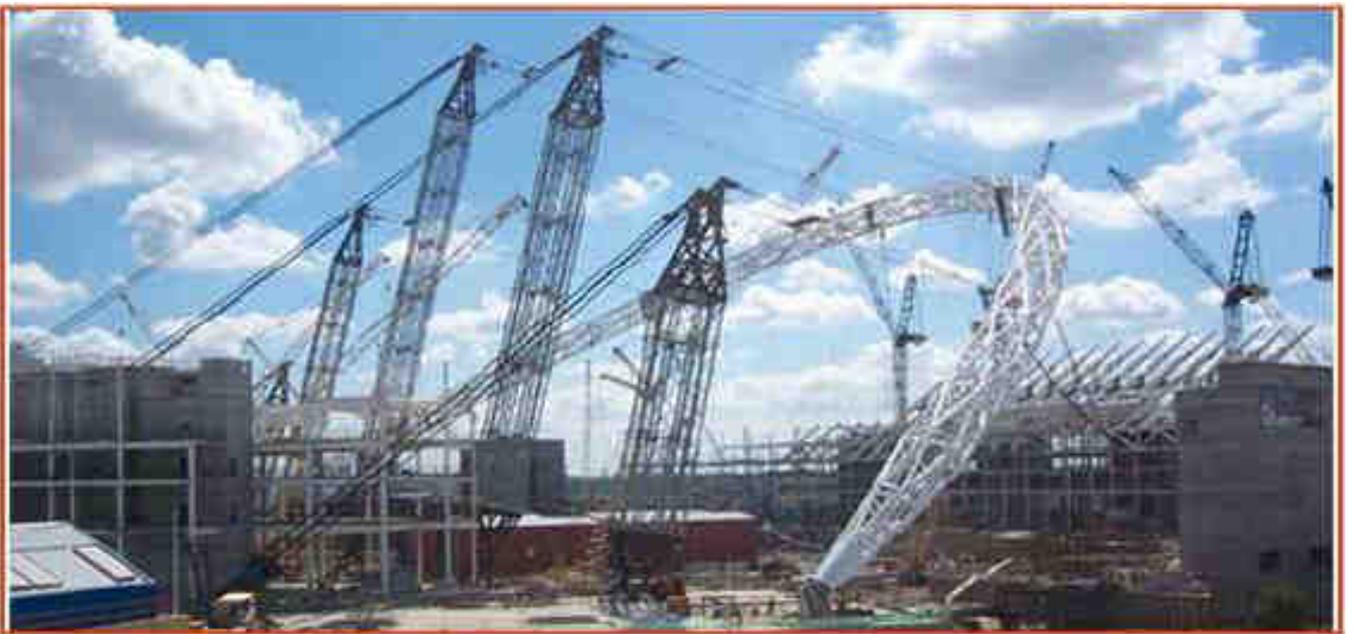
Fig 4. Turning Mast

The arch was lifted utilising five turning masts as shown in Figure 4. The longest mast was ~ 100m long and a substantial structure in its own right. The pulling forces were supplied by standard civil engineering strand jacks that have immense capability. One set of jacks was provided for each turning mast. As the jacks are activated, the turning masts rotate and exert a force on the arch causing it to be raised. Technically the force is controllable but the force applied to the arch is dictated by the stiffness of the particular attachment line. Moreover, because the lines are long they stretch a significant amount. This is important because it was not only necessary to lift the arch but also essential to maintain it in a plane during the lift to avoid dangers of buckling. To achieve both those objectives, the jacks were operated sequentially and the amount of jacking controlled by both force and displacement in a manner which lifted the whole arch but also kept it within planar tolerances. The whole operation was controlled by a 'Lift Master' and during the lift, surveys were conducted to assure that computer predictions matched reality.

The critical part of the lift was the stage at which the arch was turned through 90o. Up till then it could always have been lowered had something gone wrong but this was unlikely as the peak lifting loads took place at the moment the arch left the ground, so the entire system was in effect tested at that stage. In contrast, the first time the arch restraint lines had to work was the moment when the arch went 'over the top.' If they had failed then, the arch would have collapsed.

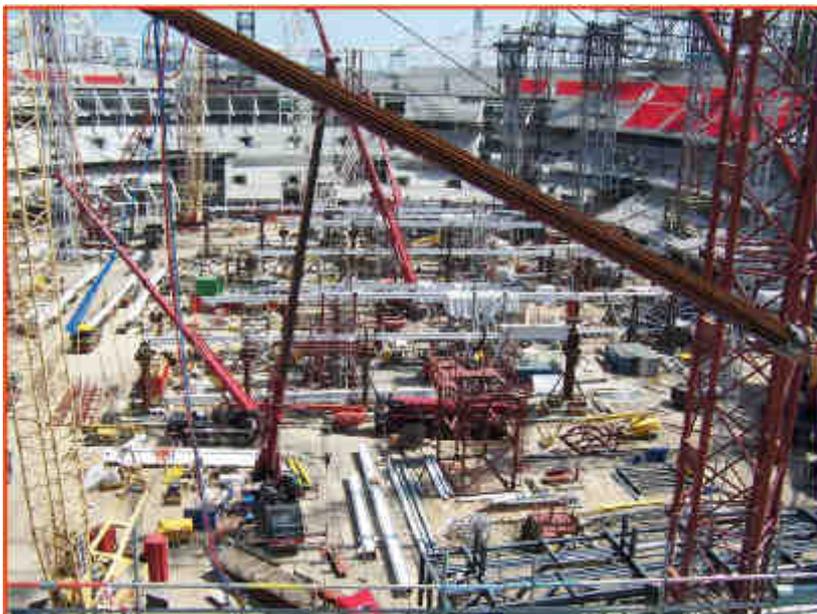
Fig 5. Crowded Pitch

A substantial lay down area is required to assemble the pieces delivered small into site and then to link them together into the larger parts that might be required for completion. Figure 5 shows the pitch at Wembley during the peak construction activity and the image is of a forest of cranes and parts under assembly. Clearly there is little room to move and careful management is required not least since pieces must be pre assembled at locations where it is possible for cranes to reach at their permitted reach and capacity.
